# Performance of sandwich composites subjected to sequential impact and air blast loading

Matthew Jackson<sup>a</sup>, Arun Shukla<sup>b,\*</sup>

An experimental study has been conducted to examine the effects of two different types of impact damage on the blast performance of sandwich composites. Sandwich composite specimens were subjected to impact by either a high velocity projectile or a low velocity drop weight. After impact, a secondary blast loading experiment was performed on the same specimens to evaluate the effects of the impact damage on the blast performance of the sandwich. Controlled blast loading was imparted using a shock tube apparatus while pressure data and high speed images of the dynamic event were captured. The experimental results showed impact damage from high velocity projectiles was most prominent on the exit face sheet of the sandwich specimens wherein damage to the core and impact face sheet, in the form of a hole, was minimal in comparison. Damage created by low velocity drop weights was concentrated on the impact face sheet and within the core adjacent to the impact face sheet. Low velocity impacts also generated de-bonding between the impact face s

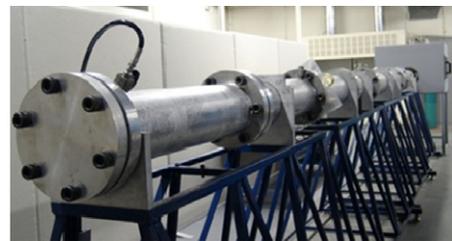
Fig. 9. Diagram and image of shock tube.

For all blast loading experiments a shock tube was utilized to simulate shock loading from an explosive event. The shock tube is a long tube open at one end and closed at the other and is divided into two main sections, the driver section and the driven section as shown in Fig. 9. The two sections are separated by a diaphragm. To operate the shock tube, the driver section is pressurized with an inert gas until the diaphragm separating the driver

section and driven section ruptures. Upon rupturing, the expansion of gas into the driven section creates a shock wave that travels down the tube toward the open muzzle where the specimen is located. The specimens were held in simply supported conditions as

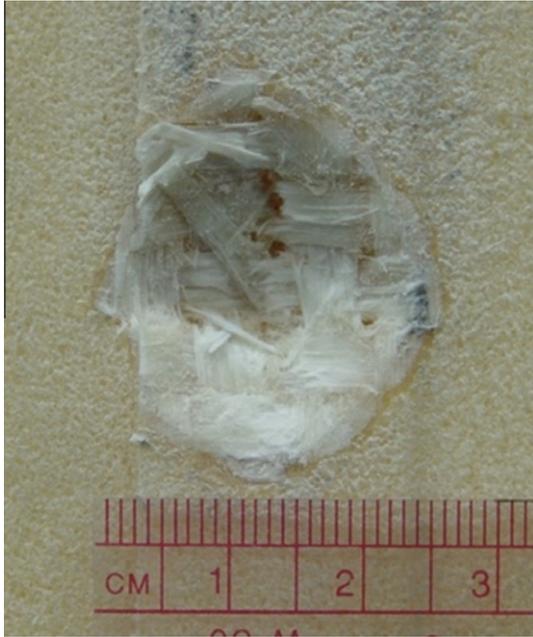
Fig. 15. Core damage due to low velocity impact.

After impact, core damage was investigated by sectioning a specimen with damage from one low velocity impact. Fig. 15 shows the impact side of the core after impact and sectioning with a band saw. The core exhibits only localized crushing due to face sheet failure. Fiber in the indentation is still partially bonded to the core.
